Callao, 14 de abril de 2023

Referencia: Expediente N° 024-2023-RCL/DPWC

**Letter of Protest**

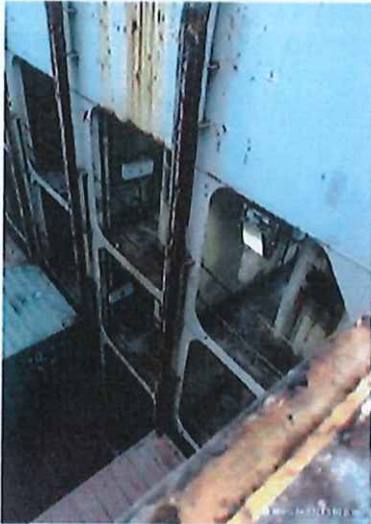
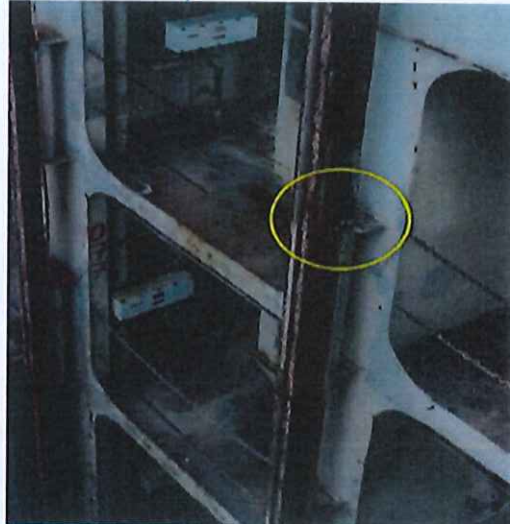
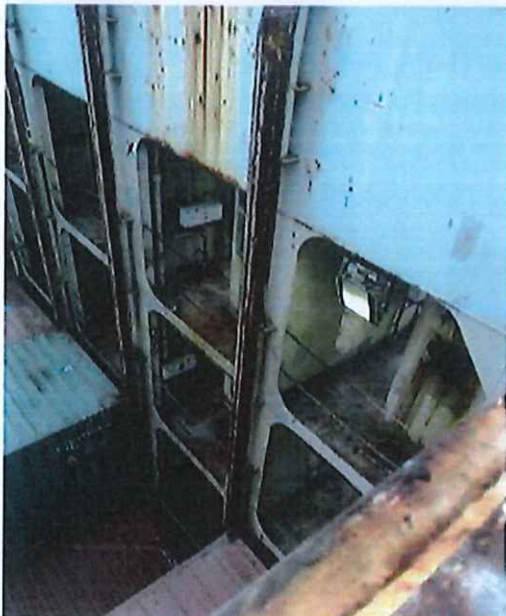
INSERTION GUIDE / BAY 02, ROW 04

As per our Vessel Safety Inspection performed, some parts of the structure of the ship under deck are fully rusted, cell guides rusted in several bay.

Then, during our operations, the following accident occurred: jamming of QC05 spreader, due to poor condition of the cell guide (bay 02 row 04). Then, the jamming and deformation of the CSNU 7994770 container would occur. These conditions pose a high risk for the stevedores, containers and the normal development of operations at our terminal.
